Inspection Report

Property Address:
123 Dreamhome
Charleston, SC 29403

Number 1 Home Inspector, LLC

Date: 12/31/2008	Time: 11:59 PM	Report ID: 123 Dreamhome New
Property: 123 Dreamhome Charleston, SC 29403	Customer: Savvy Buyer	Real Estate Professional:

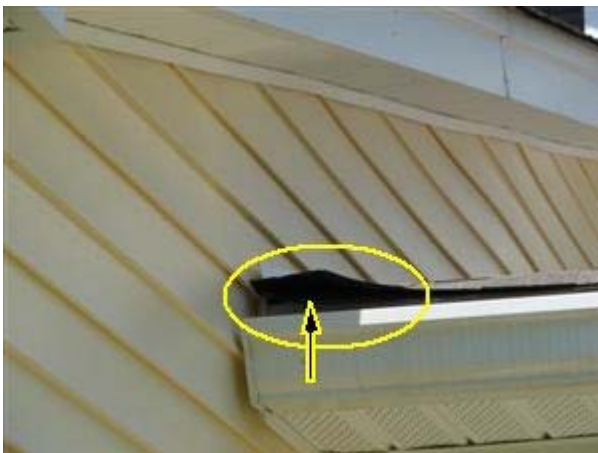
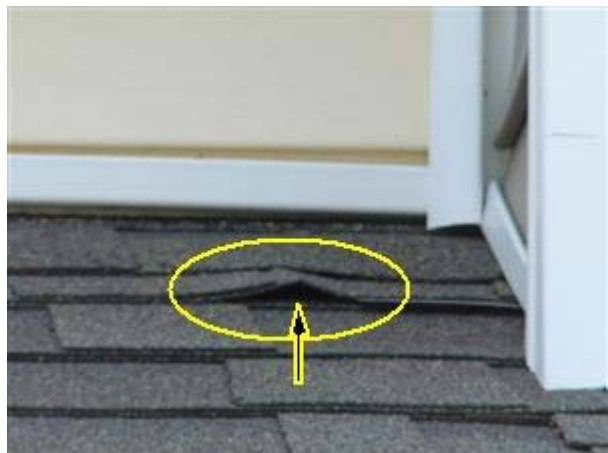
Roof covering is uplifted (wrinkled) at 2 locations. These appear likely to be caused by improperly trimmed shingles as they were pushed up against the siding. Recommend having a qualified roofer make repairs.

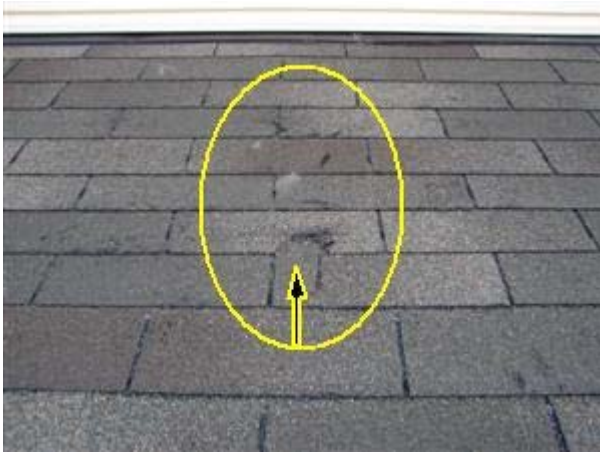
A. Picture 5

Scuffed up shingles on this new roof over the garage may need replaced.

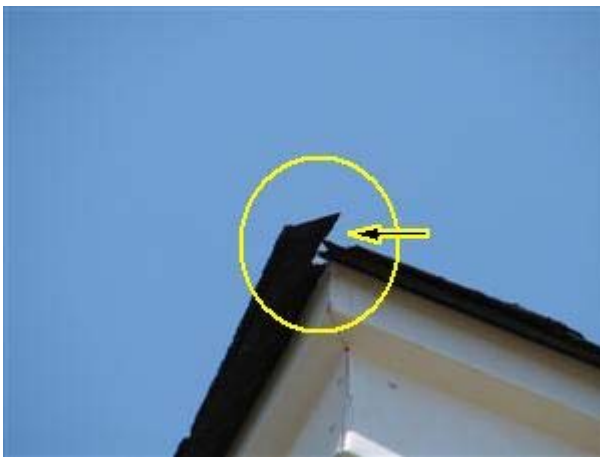
A. Picture 6

Torn shingle - right side of home - second story lower corner.

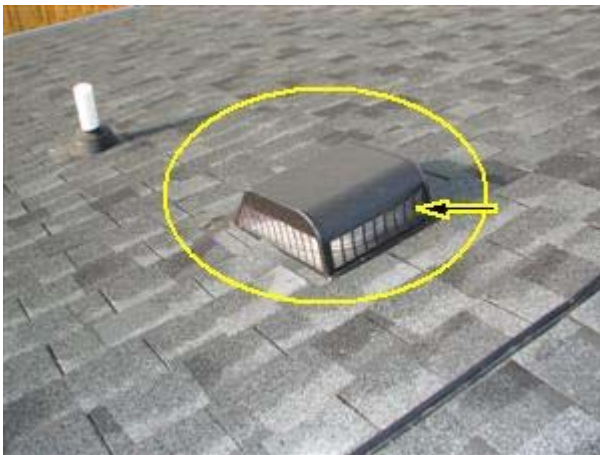
A. Picture 7

Roof vent is facing the wrong way (all 3 of them on this roof). This orientation is likely to become a water penetration each time it rains.

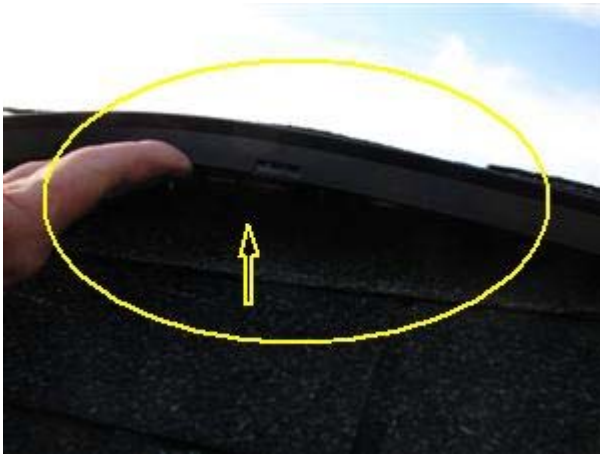
A. Picture 8

Ridge vent does not appear to be nailed down properly as evidenced by how easily it can be lifted up - multiple locations.

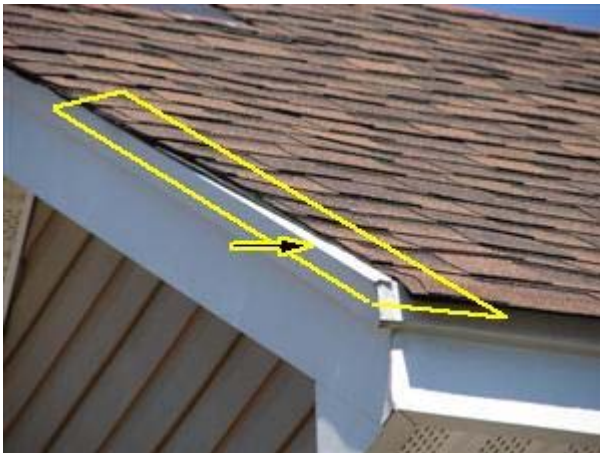
A. Picture 9

Roof covering fails to overlap the fascia at the front right corner of home. Recommend fitting new shingles into this area and trimming properly.

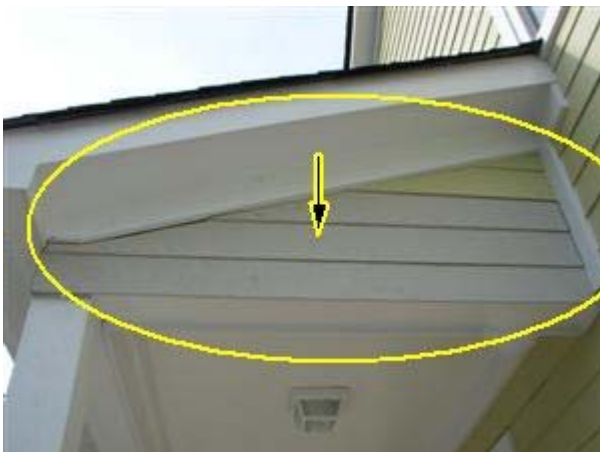
A. Picture 2

This area of the siding is not painted.

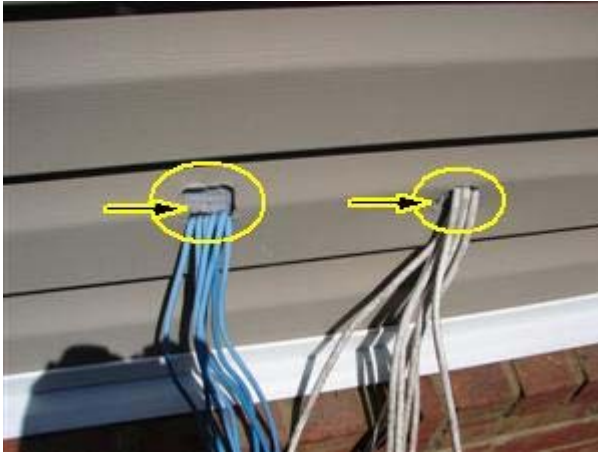
A. Picture 7

Recommend using a quality exterior caulk (such as NP1) at all cladding penetrations.

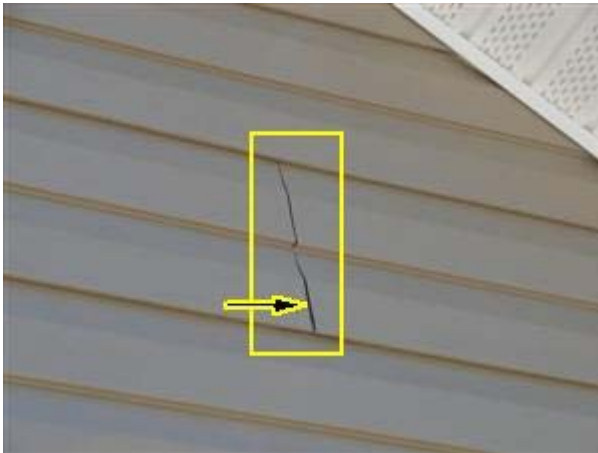
A. Picture 8

Exterior cladding fails to overlap. Recommend either sliding the pieces together or fitting another 1 foot piece over top.

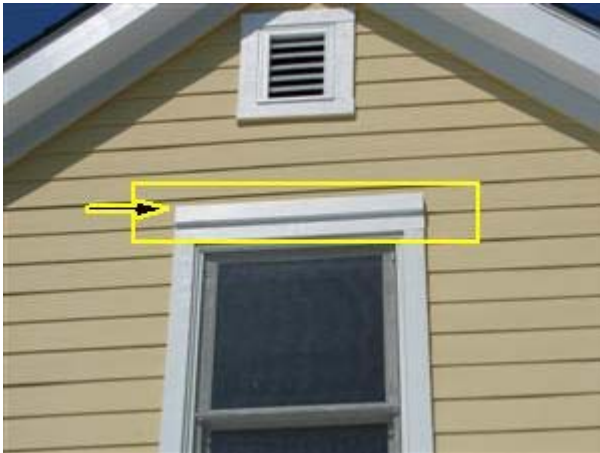
C. Picture 1

Tops of exterior windows need a metal cap on top of the window frame to help prevent moisture penetration into the wall over time.

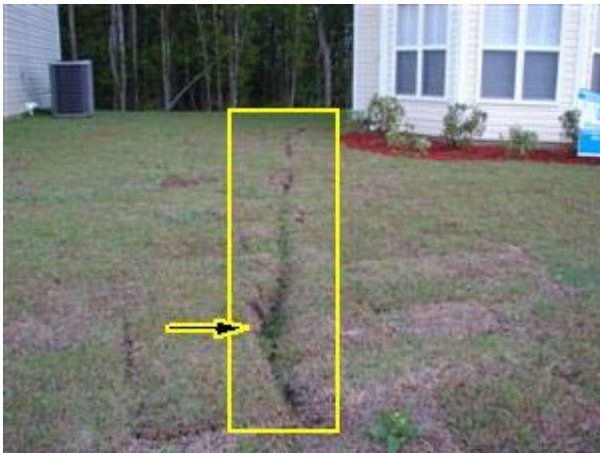
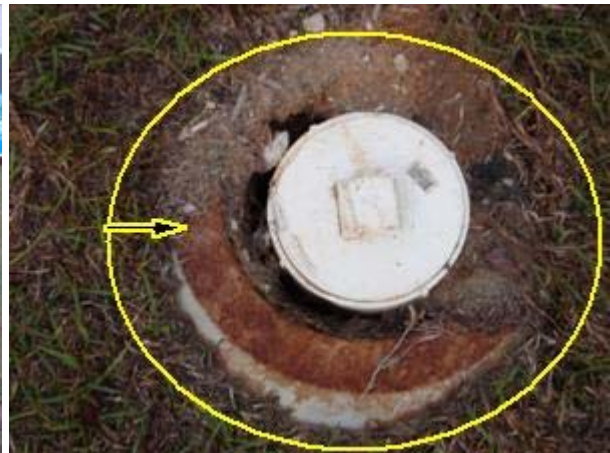
The grading near this sewer access and where the power line was buried need to be finished.

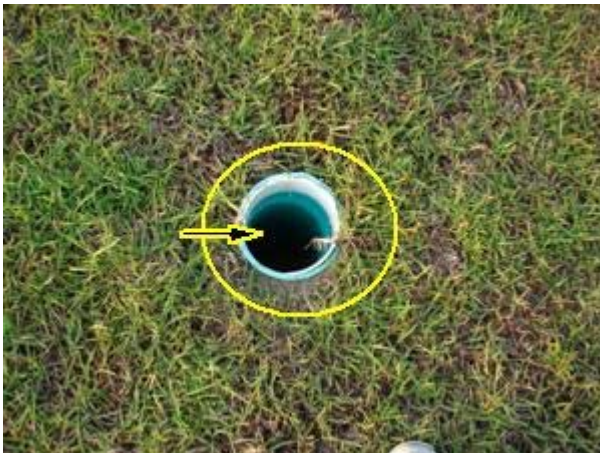
E. Picture 3

This open access drain line needs a cover - front yard.

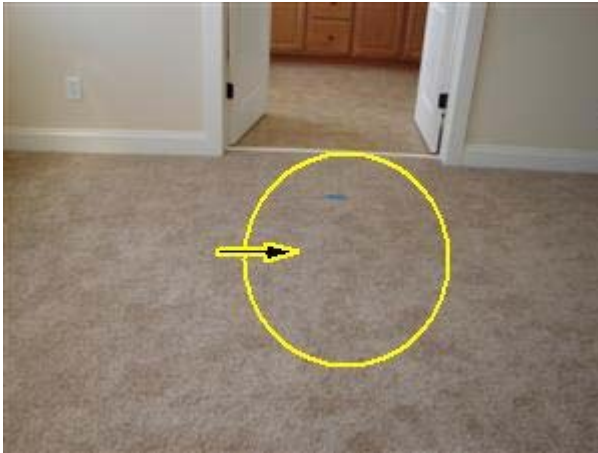
C. Picture 1

This area of the master bedroom floor is squeaky and moves visibly. It is likely that this same area of the subfloor has not been attached effectively. Recommend installing some screws through it and into the floor joists. There are other areas of squeaky flooring observed as well.

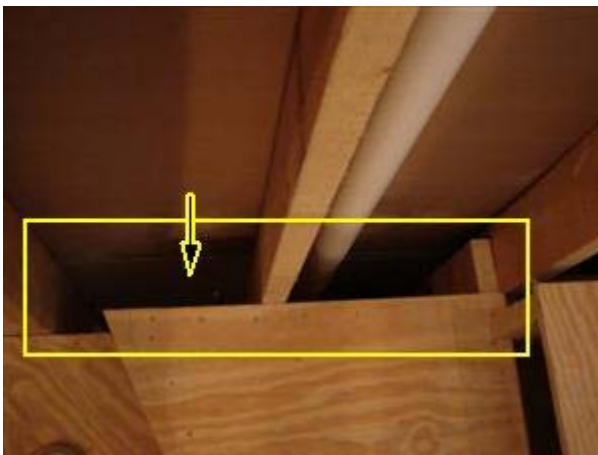
D. Picture 1

Stairways between floors need to have forelocks on each side going up to help slow the speed of a possible fire between floors.

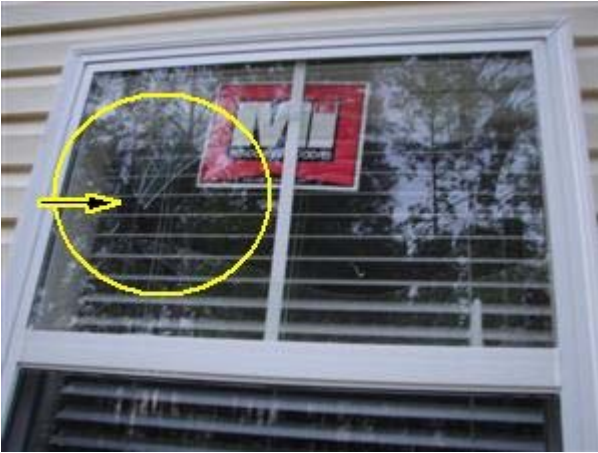
G. Picture 1
Broken window - rear side of home.

Also, no screens observed for any windows.

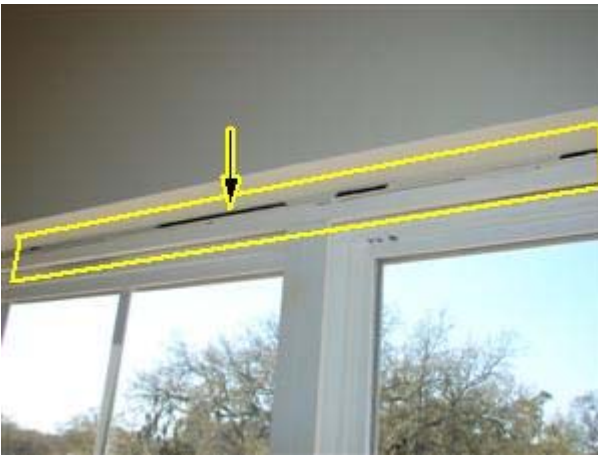
G. Picture 2
Several window frames are loosely installed. Recommend further anchoring as needed.

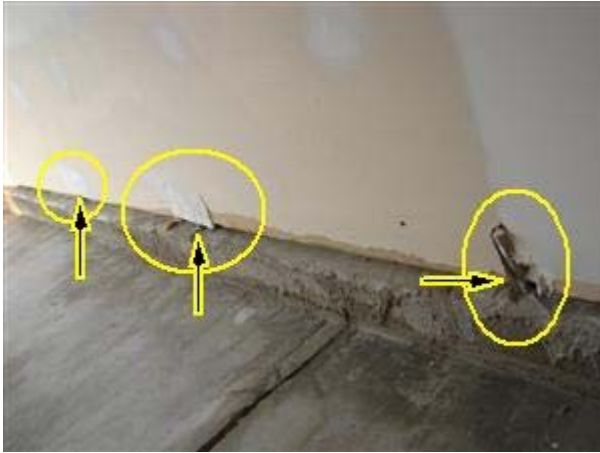
A. Picture 3

Foundation anchor bolts need to have washers and nuts installed tight to the base framing board.

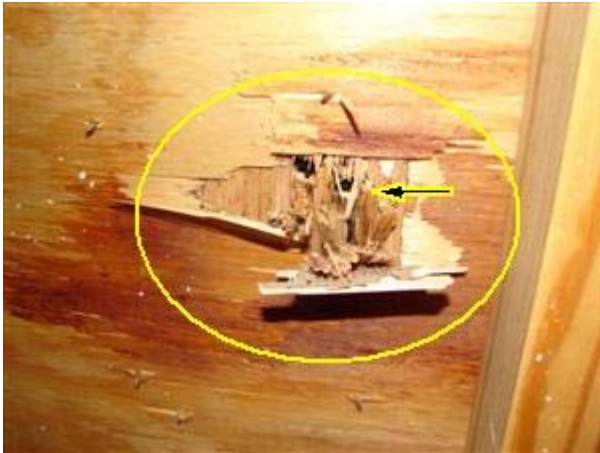
F. Picture 1

Significant damage to roof sheathing. Appears to be allowing water penetration. Recommend repair immediately.

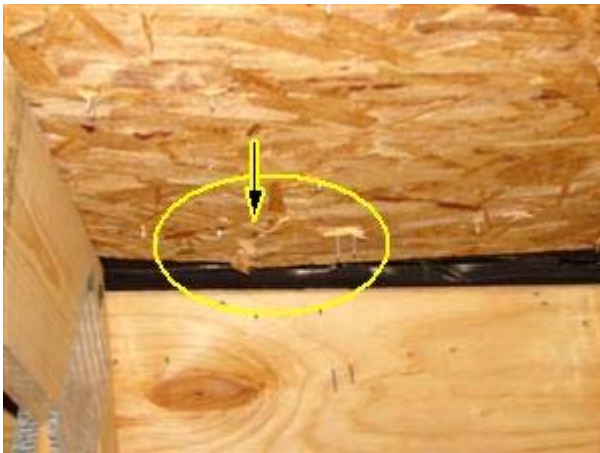
F. Picture 5

The roof sheathing at this location near the ridge vent appears to be cracked.

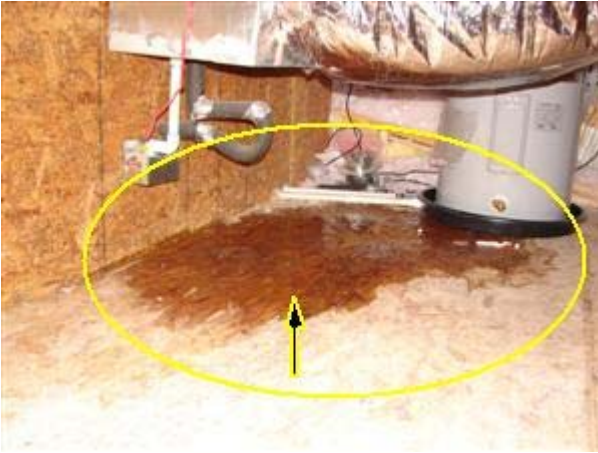
F. Picture 6

A pool of water was found in the attic space and appears to be coming from the HVAC drain line.

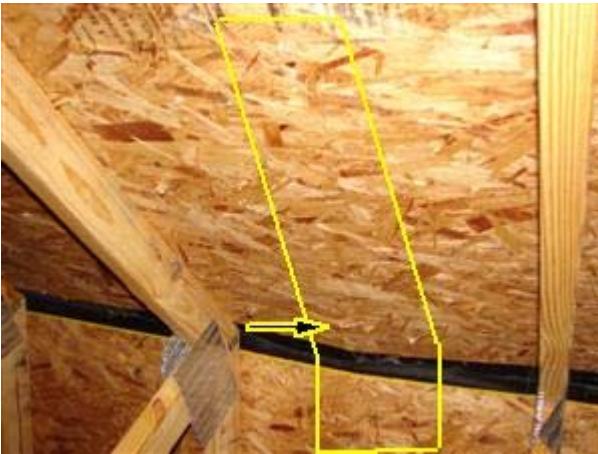
F. Picture 8

Roof sheathing is cracked on each side of the ridge at this location. This can occur when the roof sheathing is not properly nailed down (as evidenced by nails showing along side of the truss beams in this and other areas).

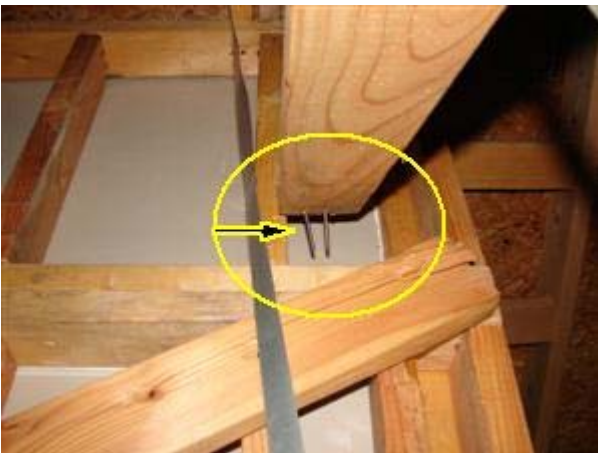
F. Picture 9

Support beam has been knocked loose near attic scuttle hole. Recommend reattachment.

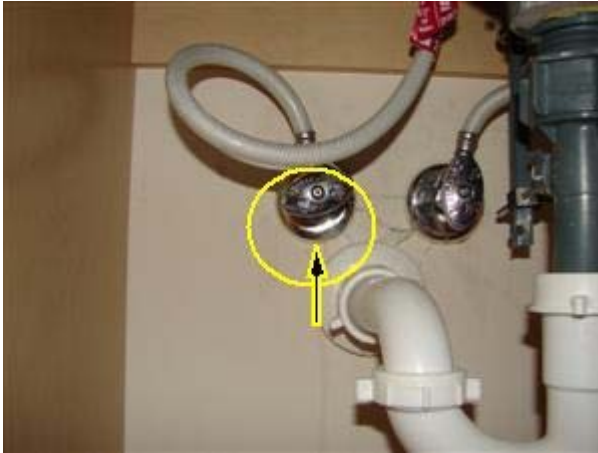
B. Picture 1

Apparent water leak at hot water supply line under first floor hall bathroom sink.

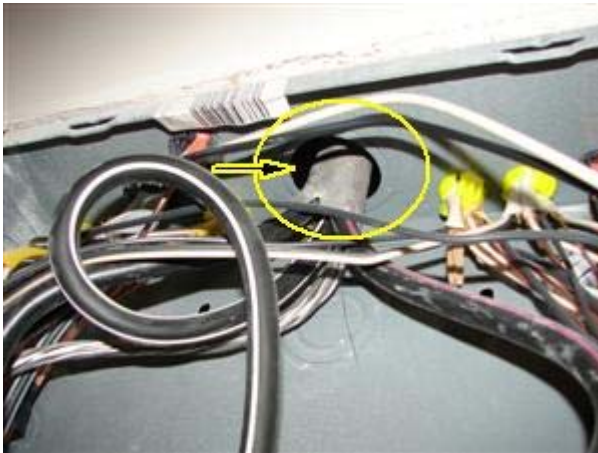
A. Picture 1

Connector missing inside of electrical panel on main service line.

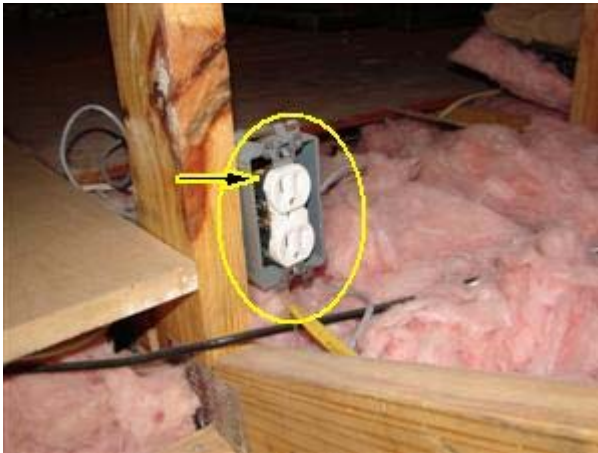
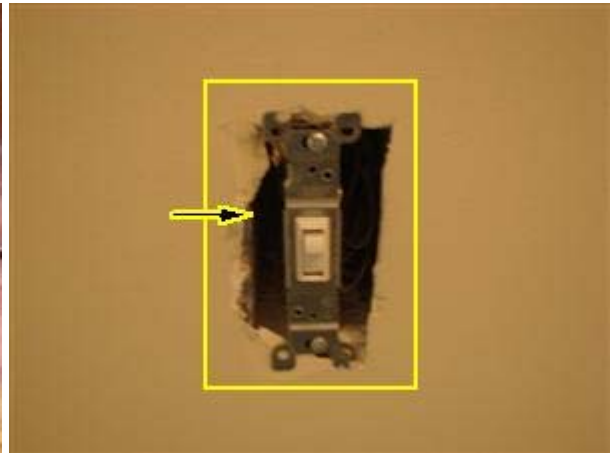
All electrical outlets need to have a cover -> shock hazard.

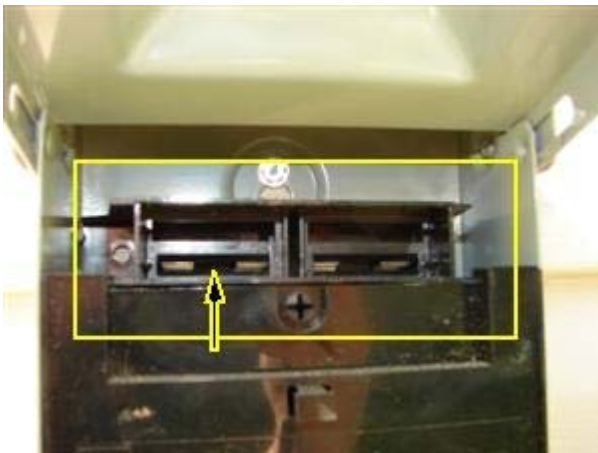
D. Picture 4

The breaker pull is missing from the exterior HVAC unit and yet a cold 46 degrees was attained from running the AC inside. This appears to indicate that the exterior breaker box is bypassed - which is a code violation.

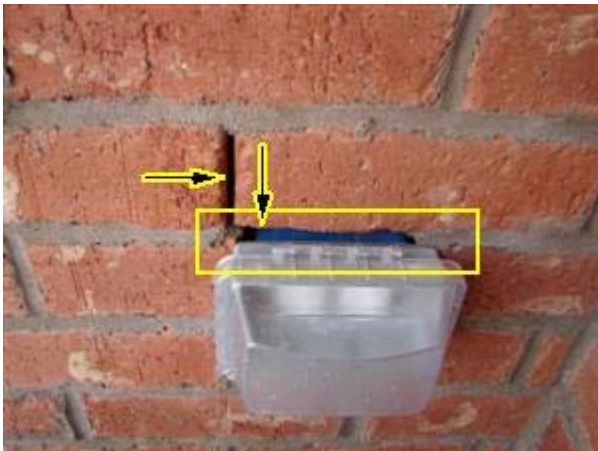
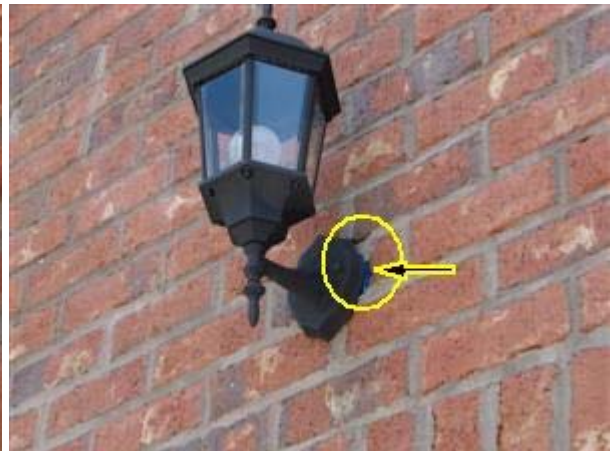
All exterior lighting fixtures and electrical outlets needs to have a weatherproof seal installed between them and the exterior cladding to help prevent water penetration to the wiring.

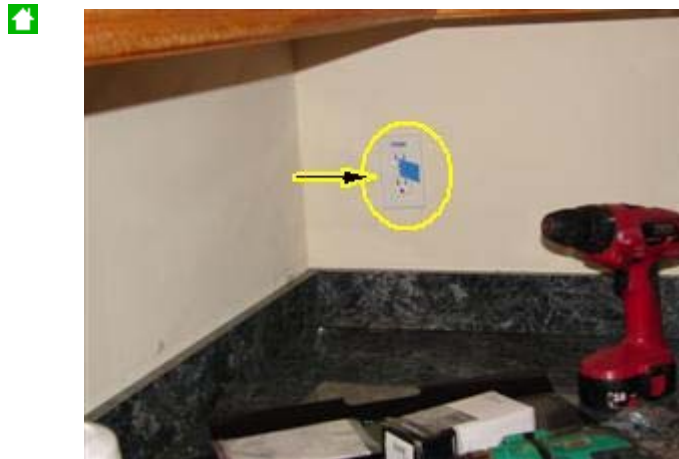
E. Picture 1

First floor bathroom outlet is not grounded and therefore the GFCI outlet will not function. One of the kitchen outlets is a GFCI, but does not trip when tested by the inspectors device. Each marked with blue tape.

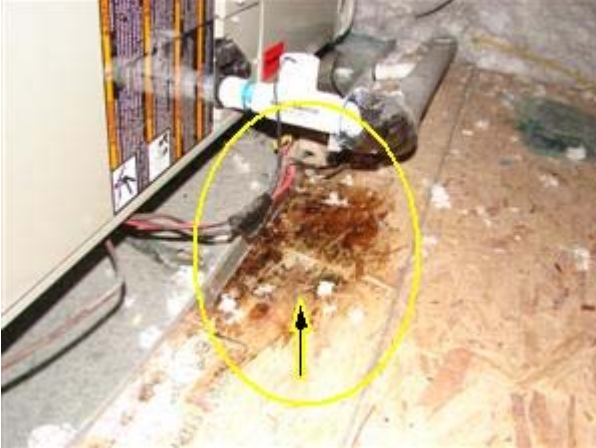
I. Picture 1

Condensate water appears to be leaking out of the primary drain line in the attic onto the attic subfloor. Recommend repair immediately.

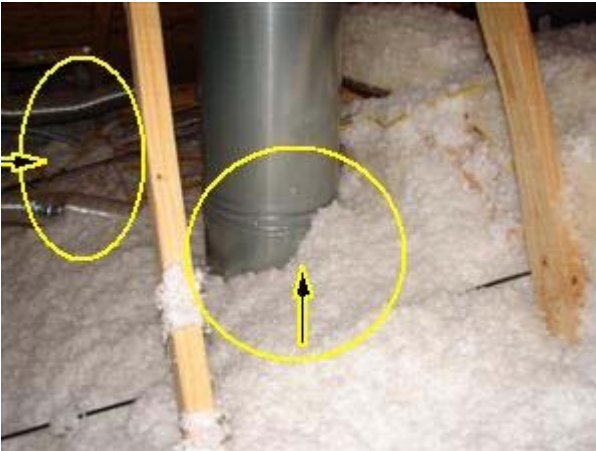
A. Picture 1

Insulation should not be touching the chimney flue - Fire Hazard.

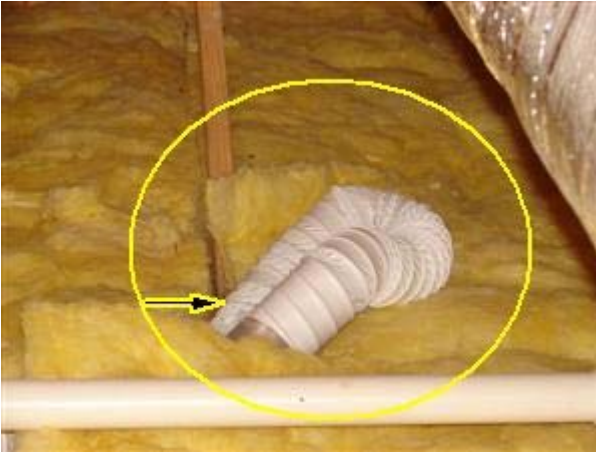
E. Picture 1

Appears that the bathroom may be venting improperly into the attic space. Recommend extending the vent line to the gable, soffit or ridge vent area.

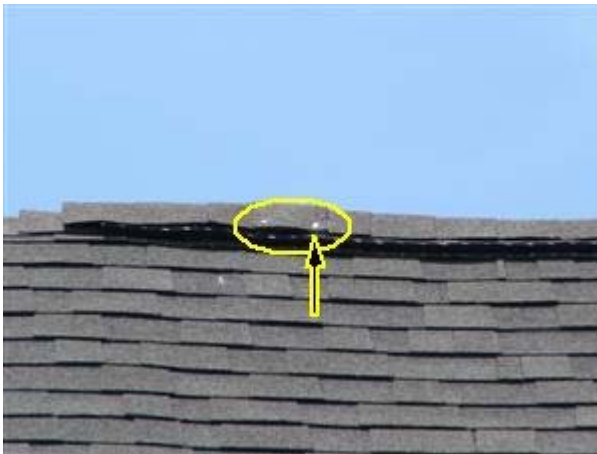
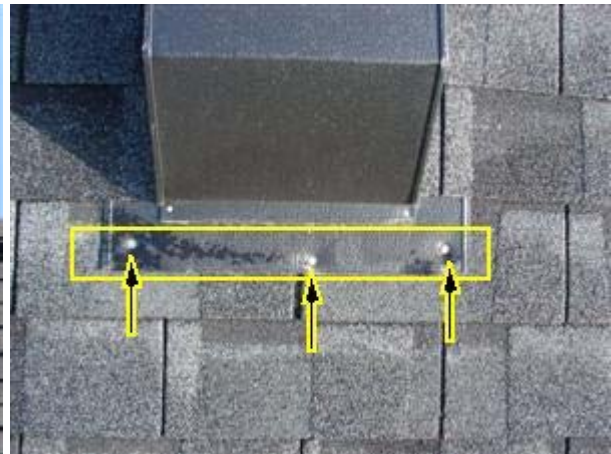
Exposed nail heads on roof covering. These may rust out (oxidize) prematurely and become a water penetration point. Recommend applying some tar to all exposed nail heads on the roof covering.

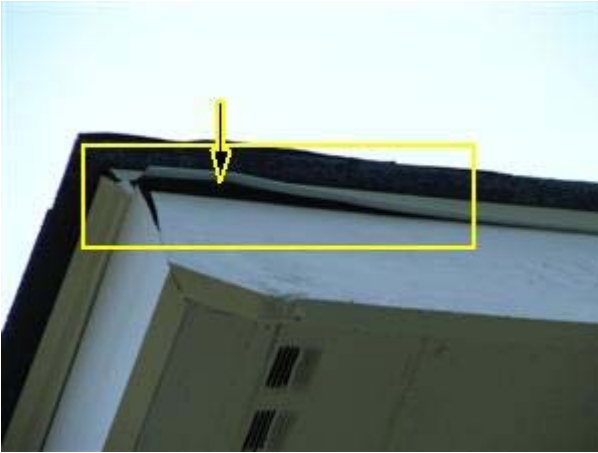
A. Picture 1

Appears that the drip edge in this area is bent out of shape and now leaves a gap.

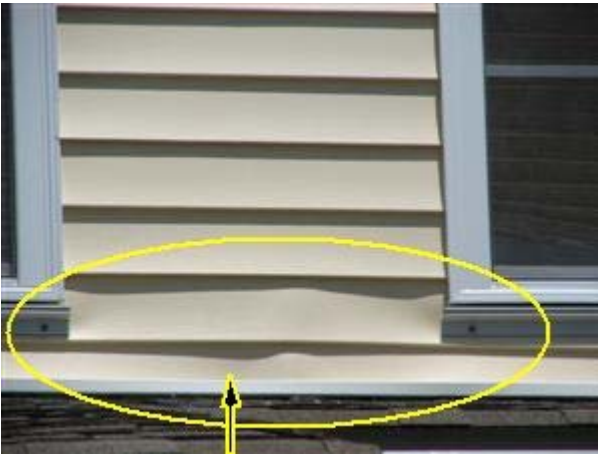
A. Picture 3

Wrinkled wavy look observed in the vinyl siding at this location. Ensure that the nails are not driven home and that the slats are trimmed properly to attain an even look.

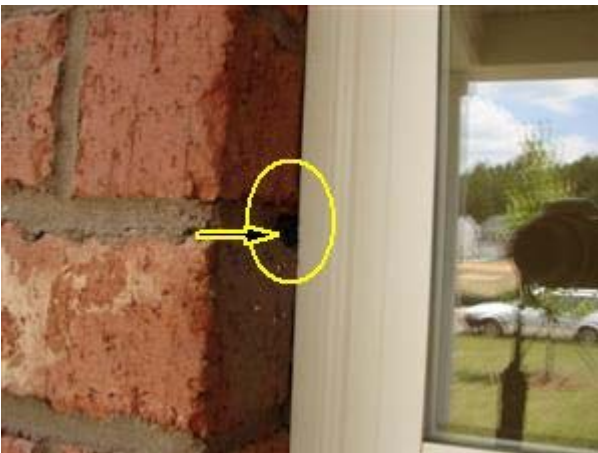
A. Picture 4

Gaps in the mortar around some window and door frames - Tyvek is showing.

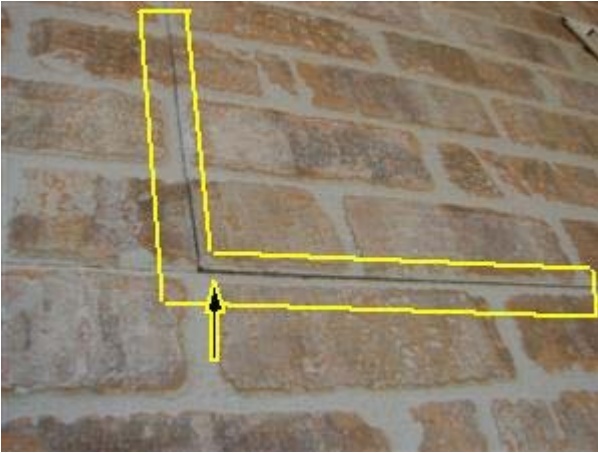
A. Picture 5

The edges of the fake brick masonry panels are visible in various locations on the front of the house.

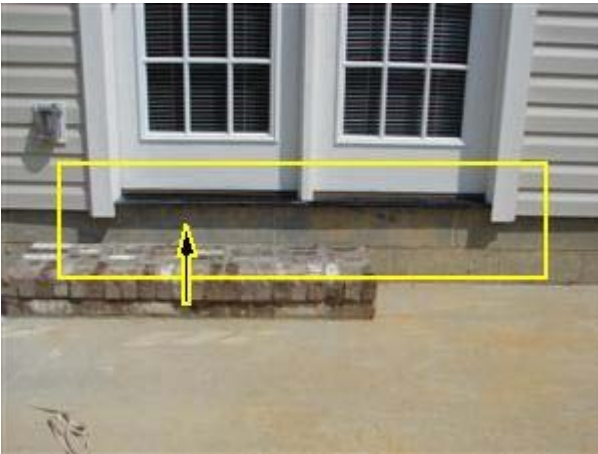
A. Picture 6

Recommend installing a support board before the rear door threshold breaks.

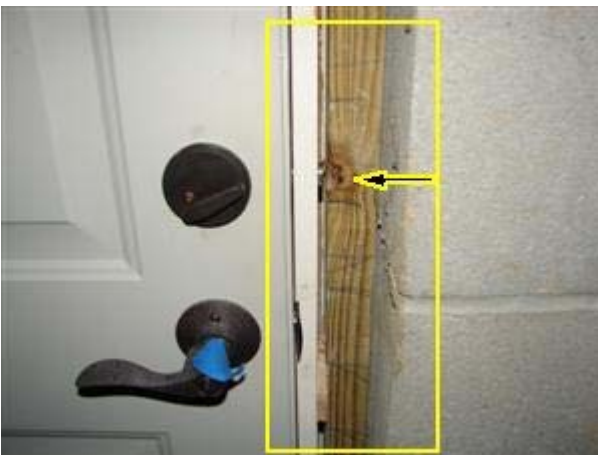
B. Picture 1

Recommend reinforcing the framing around the garage entrance door.

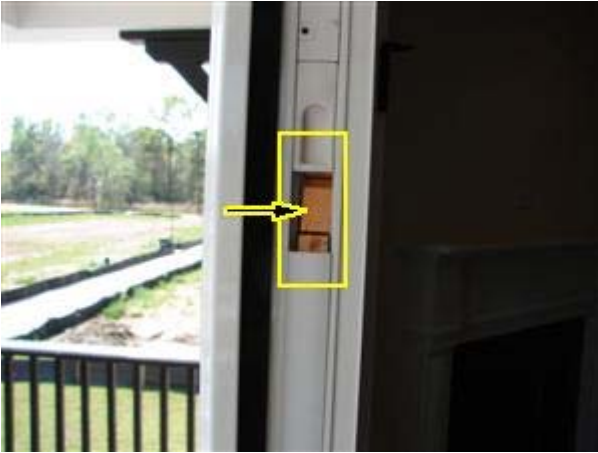
B. Picture 2

The copper tab in the balcony door is not attached properly.

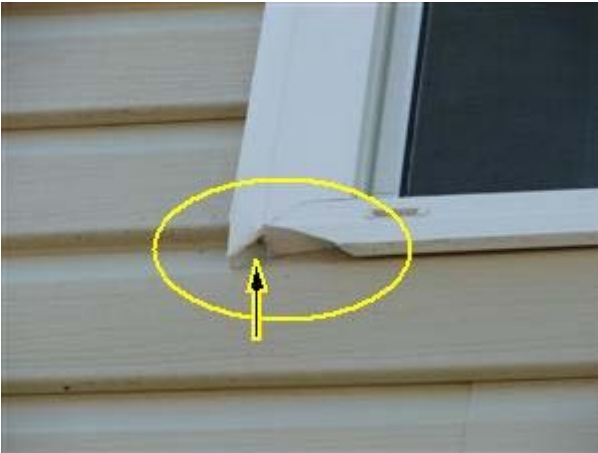
C. Picture 2

Minor damage to vinyl window frame - side of home.

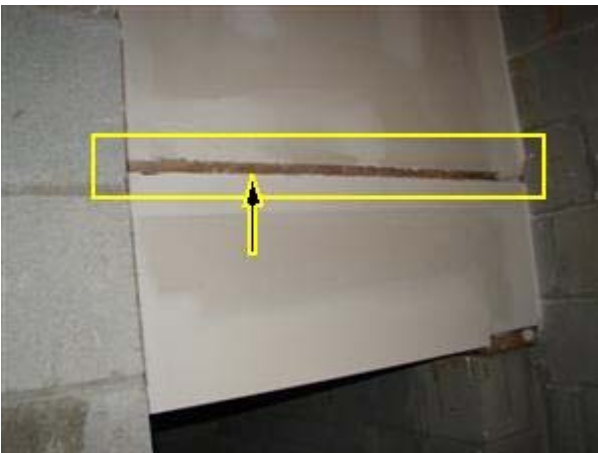
B. Picture 1

The edge of a particle board sheet shows in the garage wall. Recommend heavily painting this edge to help prevent moisture absorption into the wood that may in turn cause swelling and flaking.

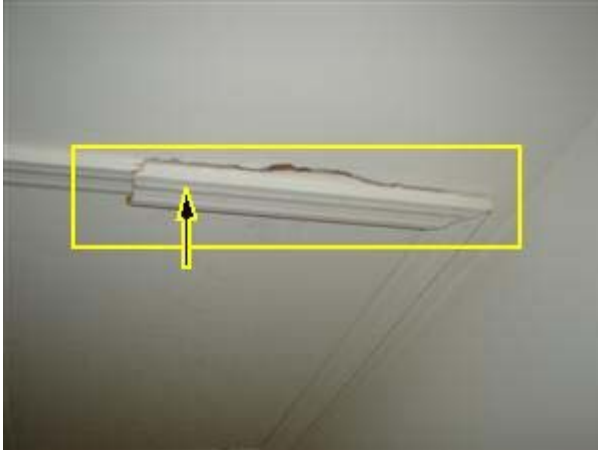
A. Picture 1

Frame around attic scuttle hole is broken.

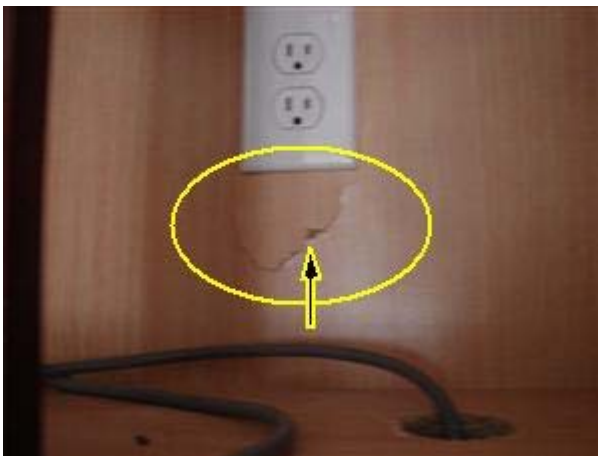
E. Picture 1

Minor damage to cabinet wall over microwave.

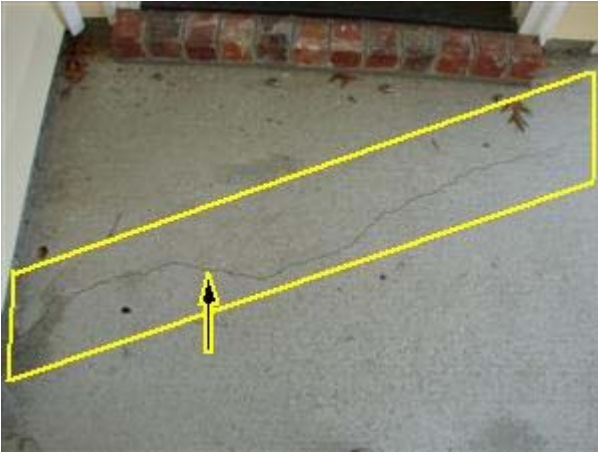
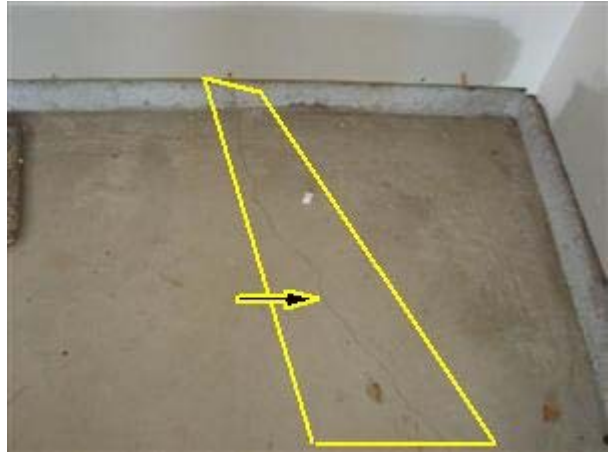
Hairline cracks observed in garage and rear patio slabs. These do not appear to be an issue.

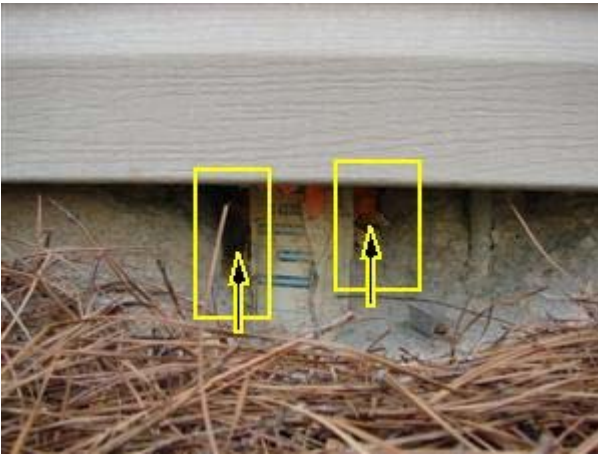
A. Picture 4

The dug out around this drain line goes pretty far back. Possible insect entry point. Recommend filling with either cement or foam.

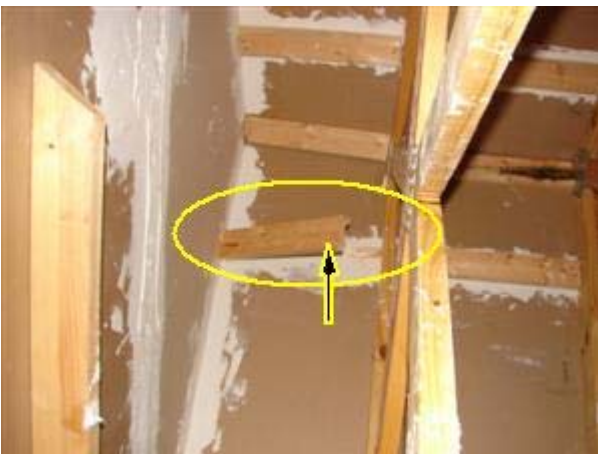
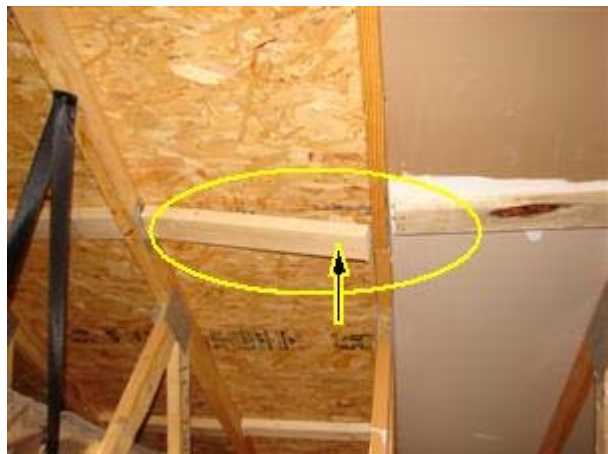
A couple of cross member supports to the roof sheathing need to be properly anchored into position.

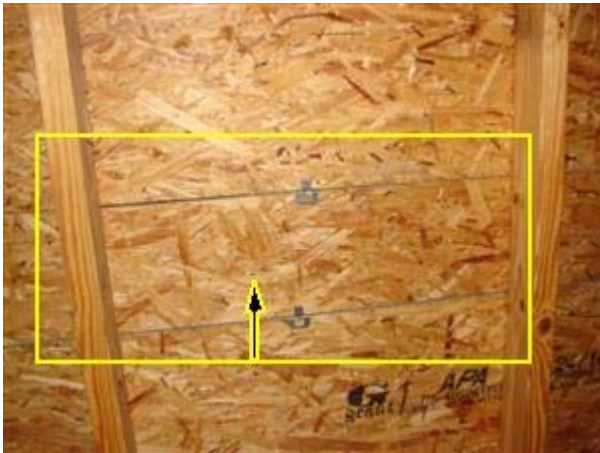
F. Picture 4

There is a narrow piece of roof sheathing spanning the length of the roof plane on both sides of the ridge. This represents a potential weak spot on the roof. Consider installing reinforcing cross members to offer additional support.

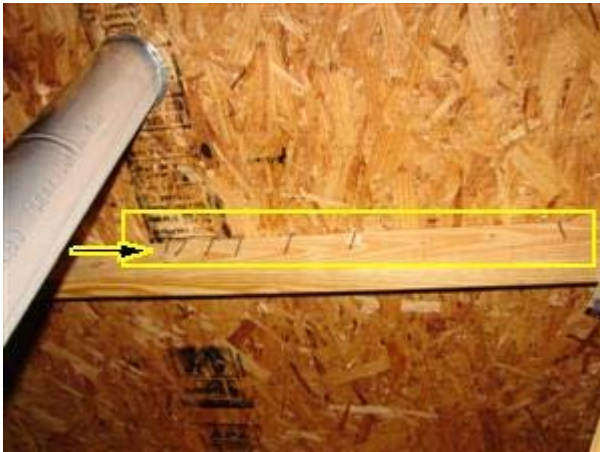
F. Picture 7

A series of missed nail penetrations appear next to this and other truss beams. This may pose a weak spot on the roof as the sheathing is not nailed down properly.

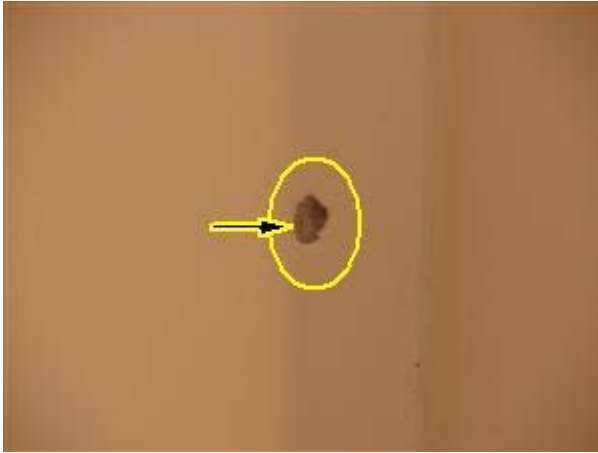
B. Picture 2

Chip in the second floor hall bath shower fixture.

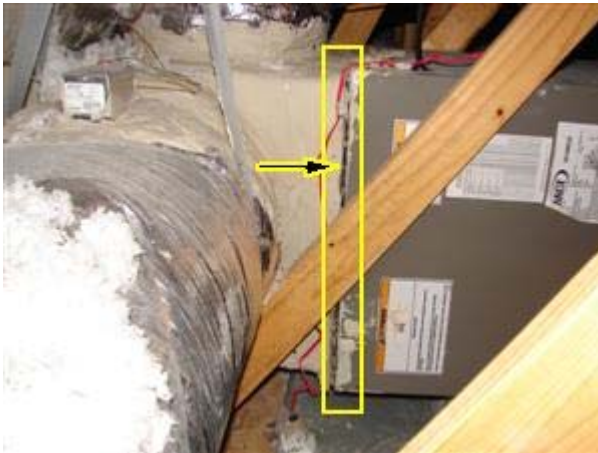
D. Picture 2

The mastic used to connect the air box to the HVAC unit in the attic appears to be coming loose. This allows cold air to escape into the attic space and will get worse over time. Recommend reaffirming this connection.

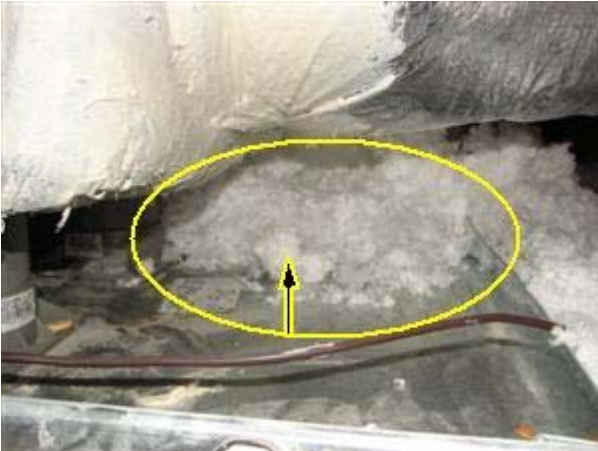
A. Picture 2

Remove the insulation from the secondary drip pan.
