Inspection Report

Property Address:
123 Dream House Blvd
Charleston, SC 29403

Number 1 Home Inspector, LLC

Date: 3/12/2007	Time: 1:00 PM	Report ID: 123 Dream House Blvd
Property: 123 Dream House Blvd Charleston, SC 29403	Customer: Mary Best	Real Estate Professional:

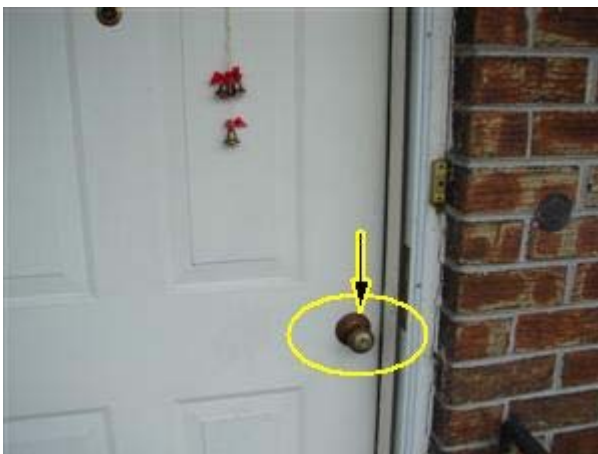
B. Picture 1

Front door lock is not functioning.

**B.** Front door lock is not functioning.
-

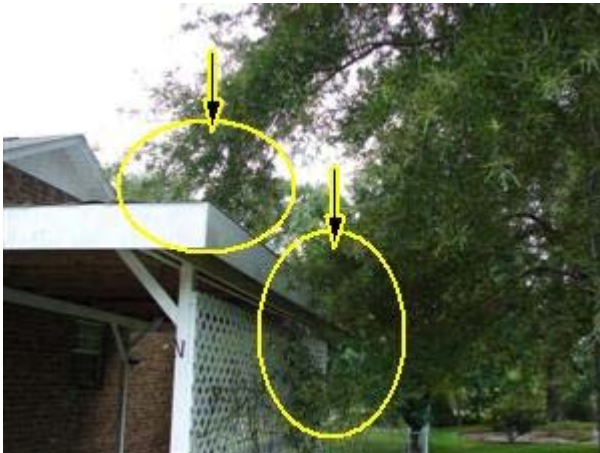
E. Picture 1

Tree limbs are beginning to encroach on the roof. Keep them cut back enough so that a strong wind cannot make them touch the roof/house.

**E.** Tree limbs are beginning to encroach on the roof. Keep them cut back enough so that a strong wind cannot make them touch the roof/house.

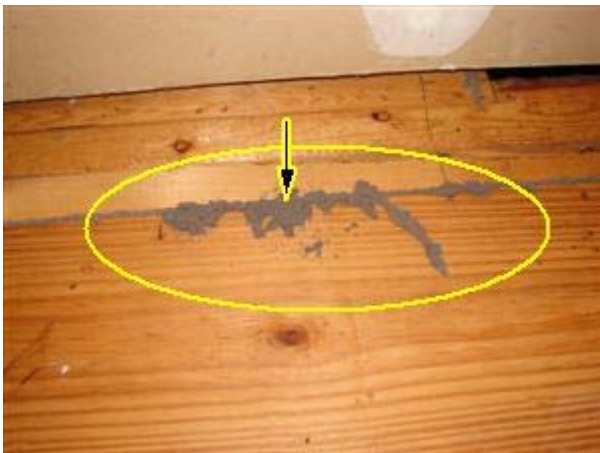
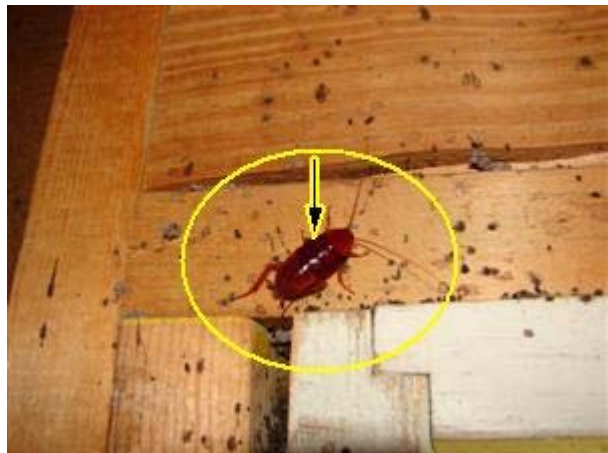
B. Picture 1

Live and dead bugs observed in various locations. Also, termite tubes were observed in the exterior utility room. Recommend a CL100.

**B.** Live and dead bugs observed in various locations. Also, termite tubes were observed in the exterior utility room. Recommend a CL100.
-

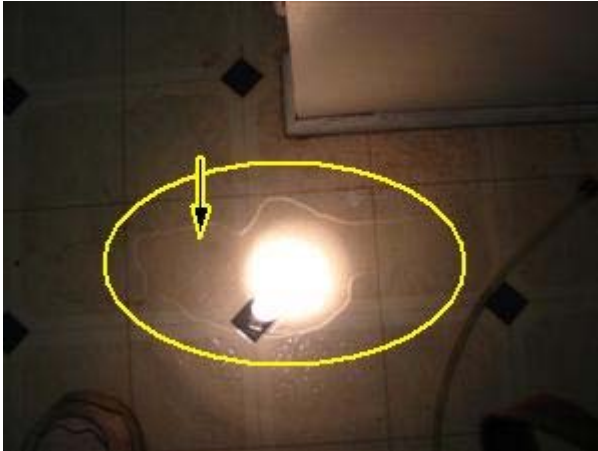
B. Picture 2

Water on the kitchen floor appears to be from the water line to the refrigerator laying on the floor.

(2) Water on the kitchen floor appears to be from the water line to the refrigerator laying on the floor.

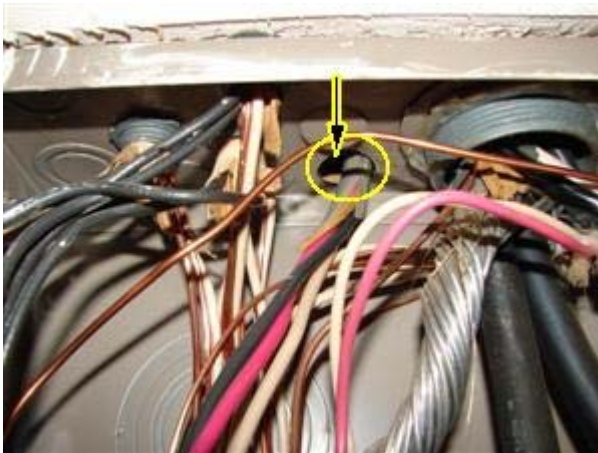
B. Picture 1

Plug(s) and/or connector(s) missing inside electrical panel

**B.** Plug(s) and/or connector(s) missing inside electrical panel
-

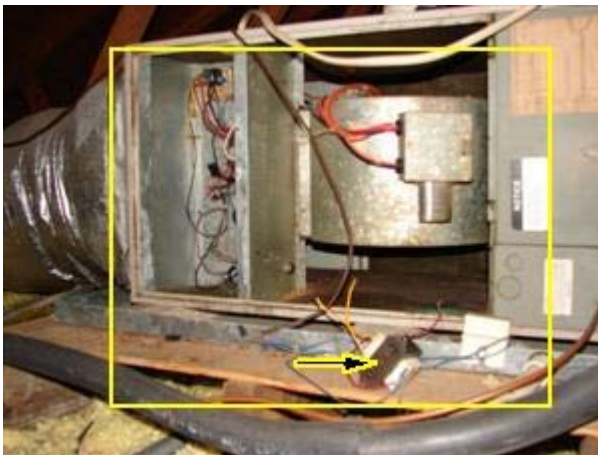
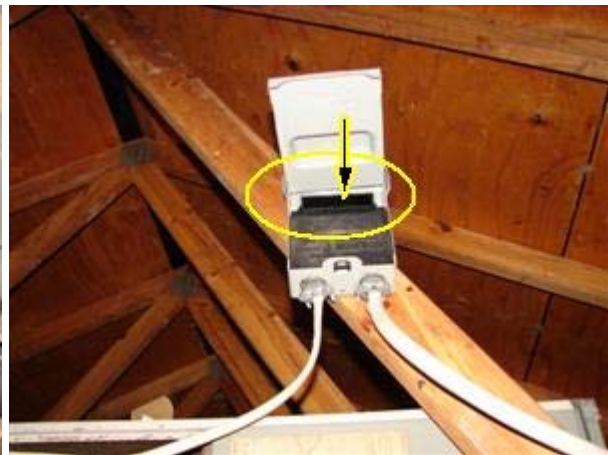
I. Picture 1

AC disconnect has been removed and the unit appears to be in a state of unfinished repair.

I. AC disconnect has been removed and the unit appears to be in a state of unfinished repair.

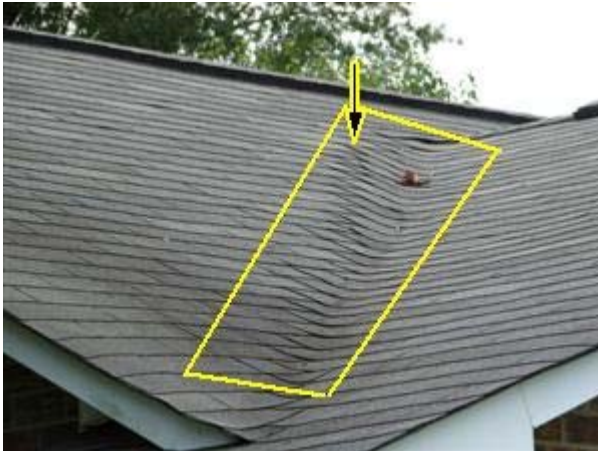
A. Picture 1

This area of valley overlay appears to be poor workmanship, although no water stains were observed in the attic (limited access inside attic due to no floor).

A. This area of valley overlay appears to be poor workmanship, although no water stains were observed in the attic (limited access inside attic due to no floor).

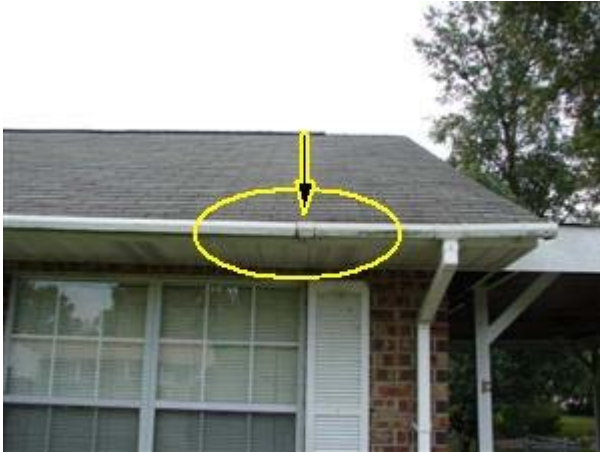
D. Picture 1

This part of the gutter is too low and will leak here.

D. This part of the gutter is too low and will leak here.

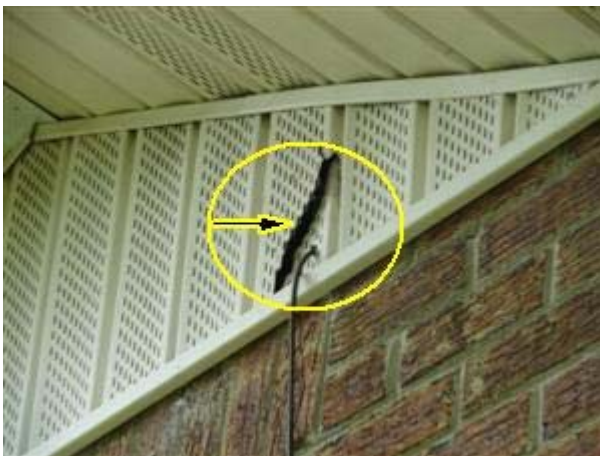
A. Picture 1

Break in gable vent cover is enough to allow critters to enter.

**A.** Break in gable vent cover is enough to allow critters to enter.
-

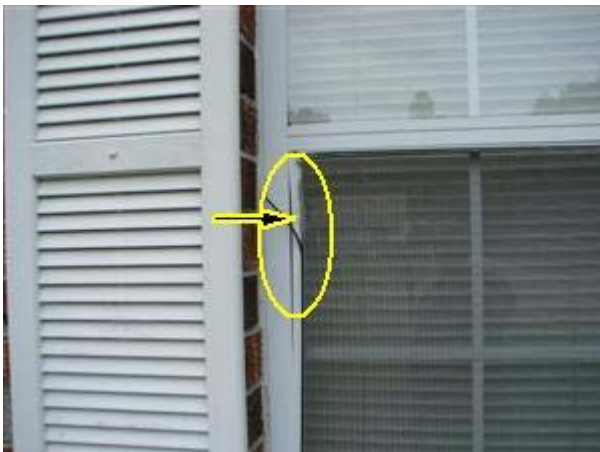
C. Picture 1

Bent window screen frame.

**C.** Bent window screen frame.
-

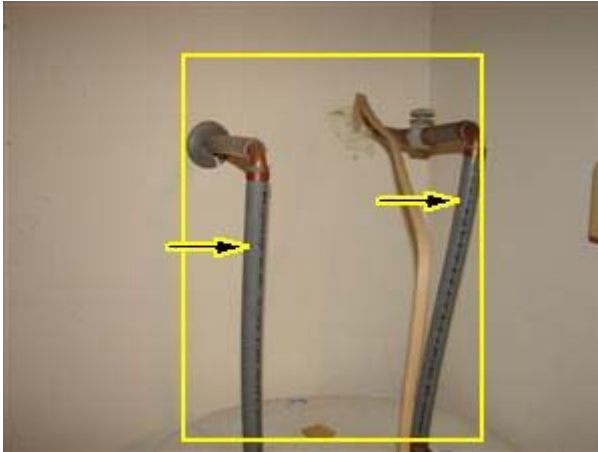
B. Picture 1

Polybutylene plastic plumbing supply lines (PB) are installed in the subject house. Polybutylene has been used in this area for many years, but has had a higher than normal failure rate, and is no longer being widely used. Copper and Brass fittings used in later years have apparently reduced the failure rate. This subject house has brass fittings. For further details contact the Consumer Plumbing Recovery center at 1-800-392-7591 or the web at <http://www.pbpipe.com>

Polybutylene piping is present in the structure. Although no leakage was observed at the time of inspection, these lines are prone to leakage and have been involved in litigation.

The Polybutylene system may become weak and fail without warning causing damage to the building structure and personal property.

B. (1) Polybutylene plastic plumbing supply lines (PB) are installed in the subject house. Polybutylene has been used in this area for many years, but has had a higher than normal failure rate, and is no longer being widely used. Copper and Brass fittings used in later years have apparently reduced the failure rate. This subject house has brass fittings. For further details contact the Consumer Plumbing Recovery center at 1-800-392-7591 or the web at <http://www.pbpipe.com>

Polybutylene piping is present in the structure. Although no leakage was observed at the time of inspection, these lines are prone to leakage and have been involved in litigation.

Polybutylene has been involved in class action law suits
The Polybutylene system may become weak and fail without warning causing damage to the building structure and personal property.

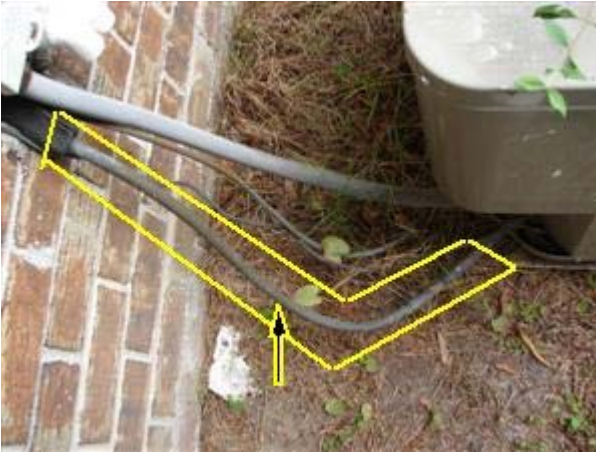
G. Picture 1

AC low pressure line has damaged / missing robotex insulation. Needs replaced

**G.** AC low pressure line has damaged / missing robotex insulation. Needs replaced
